FINAL REPORT

February 6, 2004

Assessment of the February 2003 Ice Storm

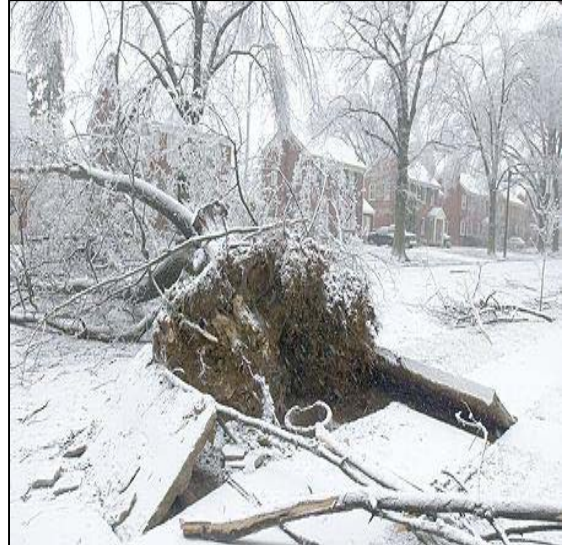
PHOTO 1: Uprooted Tree in Lexington, KY

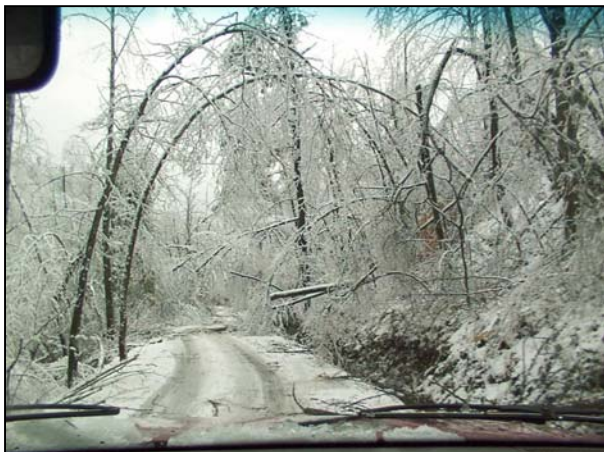
A little ice goes a long way. Ice will build up on all exposed surfaces, but tree limbs and wires are the critical surfaces that impact electric facilities. As ice reaches a thickness of more than 1/4 inch, trees will begin to sag and start breaking. Very flexible trees such as birch trees will often sag to the ground without breaking. See **PHOTO 3**. When trees

PHOTO 3: Trees Start Sagging to the Ground as the Vertical Weight of the Ice Increases

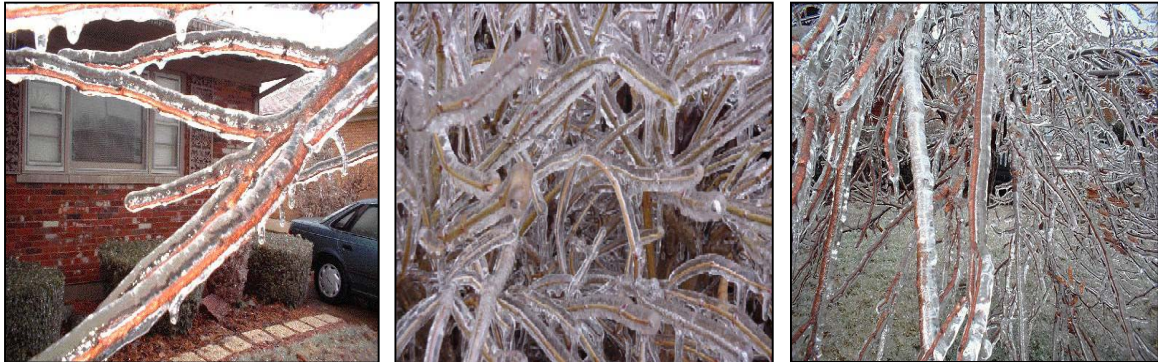
The percentage increase in the weight of tree limbs can be even more drastic due to the complexity of limb patterns that allow ice to build up more as a mass than as individual limbs. See **PHOTOS 4, 5 and 6**.

PHOTOS 4, 5 and 6: Ice Loading on Trees and Limbs

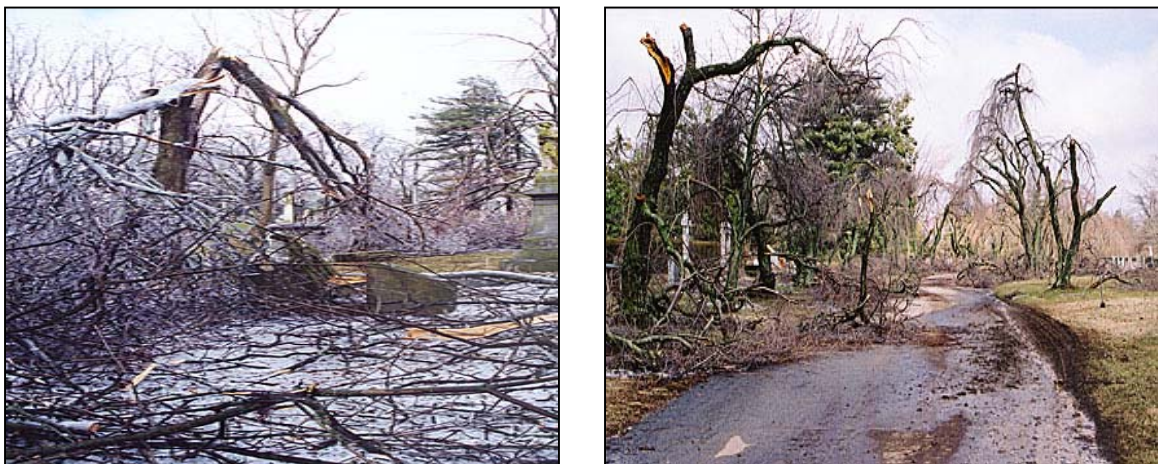
PHOTOS 7 and 8: Trees Damaged by Weight of Ice – Lexington, KY

cause significant breakage of large limbs. The 2-inches of radial ice deposited during the February storm increased normal branch and tree weights by a factor of as much as 120. See **PHOTO 7 and 8**. Branch failure occurs when loading exceeds wood resistance or when constant loading further compromises a weakened area in a branch. Strong winds increase the potential for damage from ice accumulation. Various tree species react differently to the increasing weight of the ice. See **APPENDIX B**. Because falling trees and limbs are a major factor in the damage of a utility's overhead facility the proper attention must be afforded to tree growth near electric lines. This will be discussed in greater depth in the section dealing with R/W maintenance.

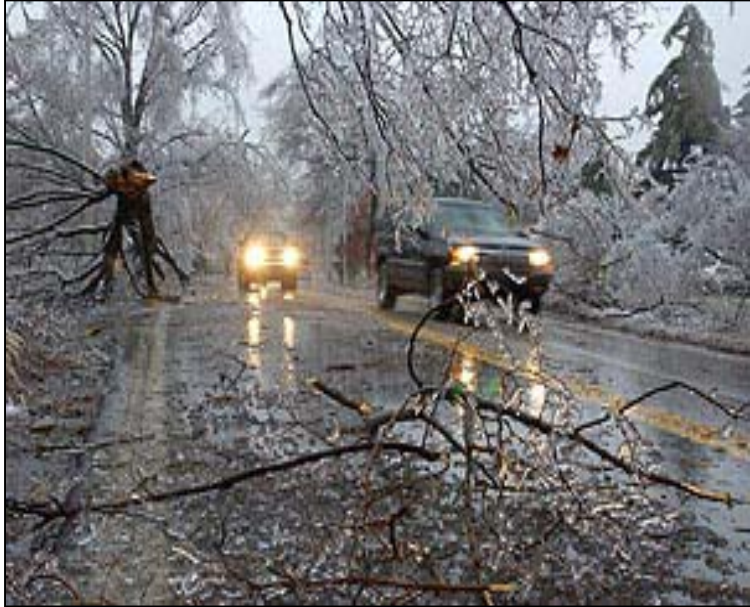
PHOTO 11: Fallen Trees on the Streets of Lexington, Kentucky Made Timely Response to Outages Difficult and Dangerous

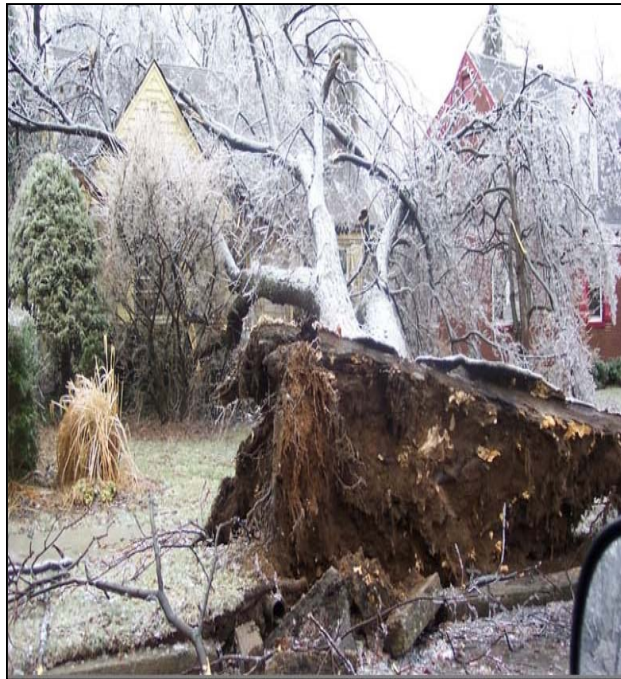
PHOTO 16: Lexington, KY ~ Uprooted Tree

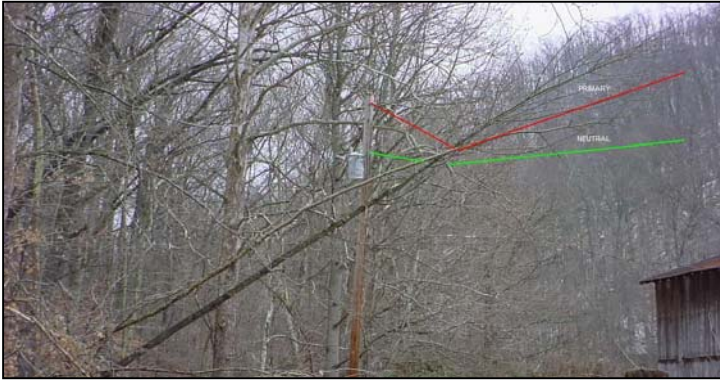
PHOTO 17 - Lewis County, KY ~ Tree on Line

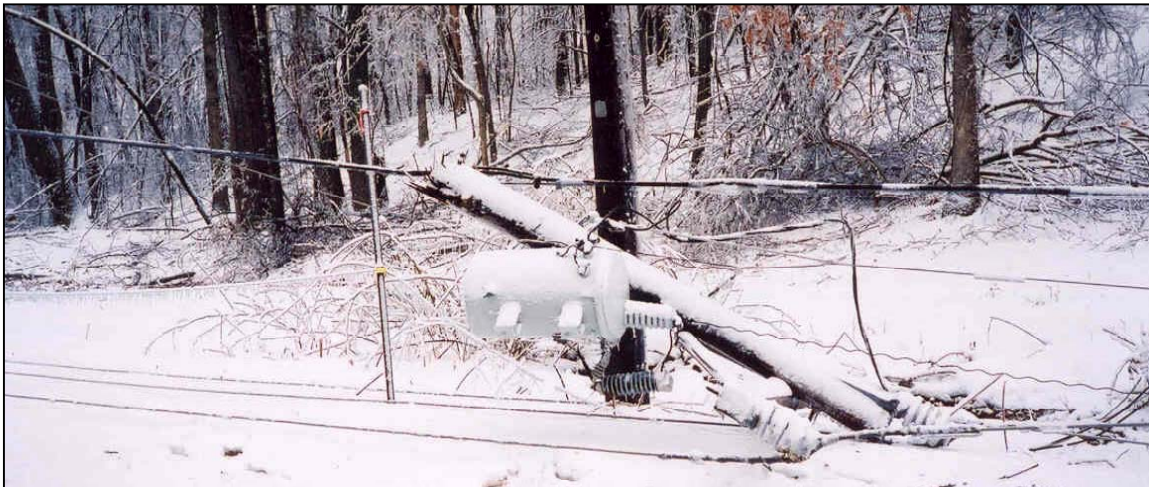
PHOTO 18 – Fleming County ~ Damaged Material Left While Repair Work Continued Elsewhere

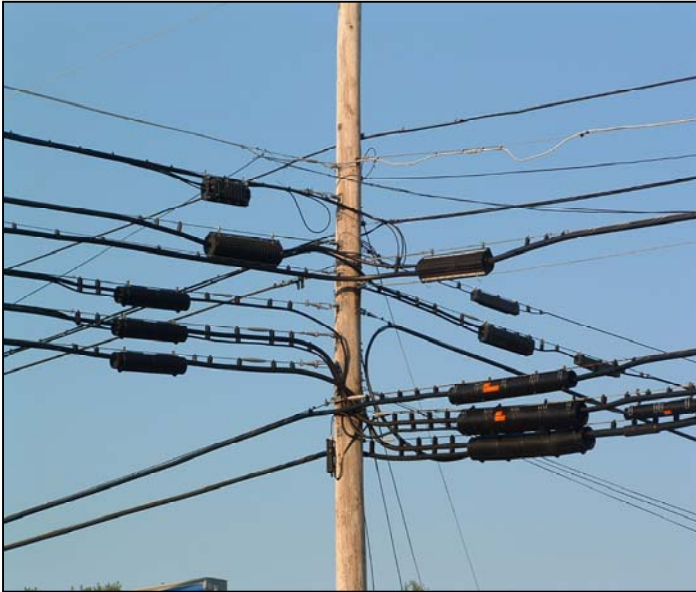
PHOTO 19: Questionable Joint Attachment Loading

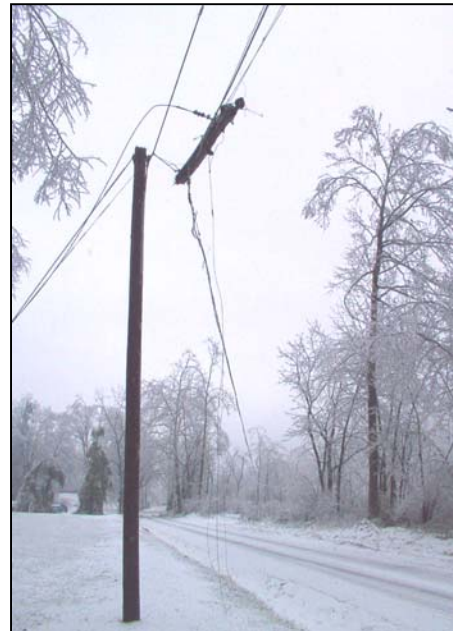
PHOTO 20: Pole Broken at Point of Joint Attachment by possible improper loading

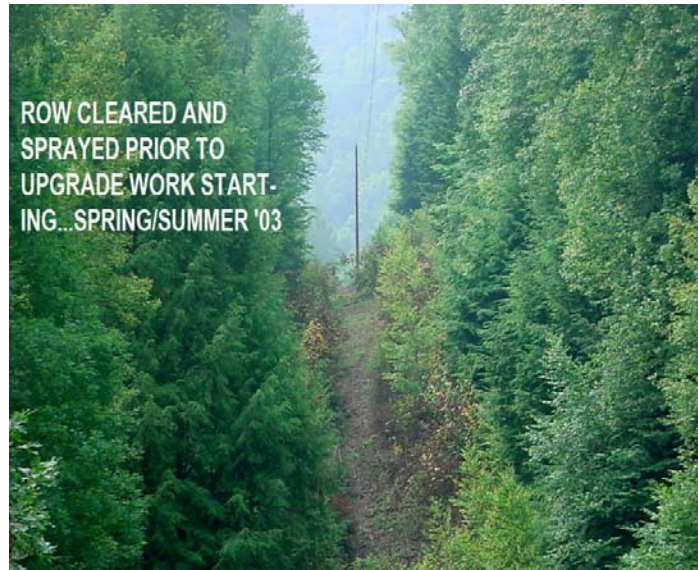
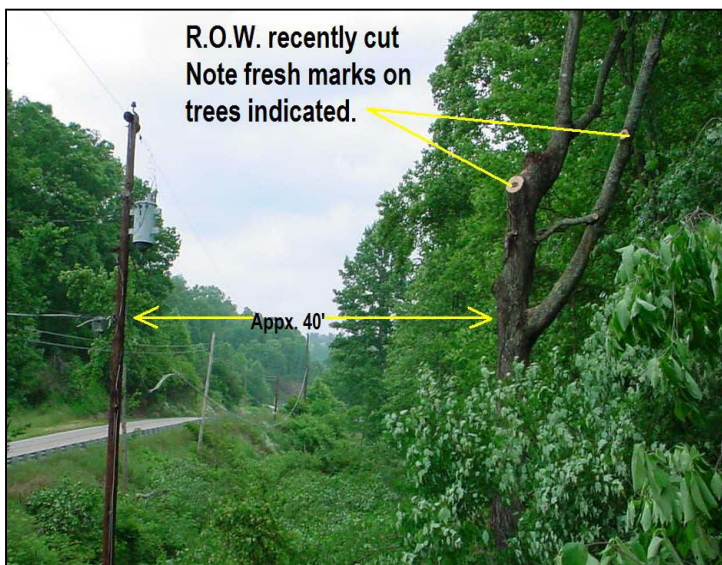
Photo 23: Narrow R/W

Trimmed R/W widths differ throughout the state. There is currently no “standard” cut width mandated by Kentucky law or by NESC codes. Typical best practices place three-phase lines at 40-foot widths and single-phase lines in 30-foot wide R/W's. Some variety in cutting practices is based on company VM policies, geography / terrain, easement widths, line voltages, property owner issues, etc. **PHOTOS 23 and 24** depicts the varied width of

PHOTO 24: Recently Trimmed R/W

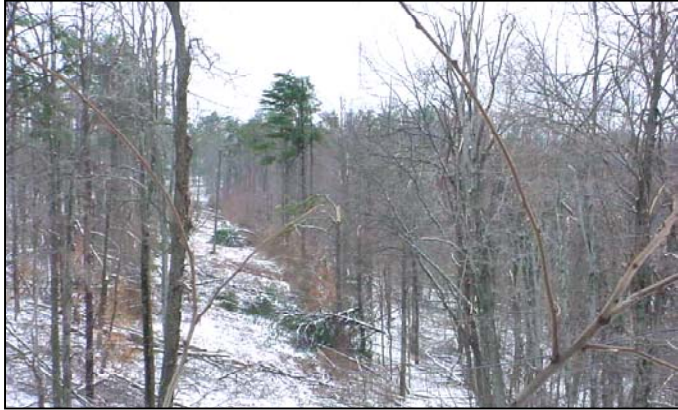
PHOTO 32: Normally Adequate R/W Wasn't Enough to Ward Off Devastation Inflicted by this Ice Storm

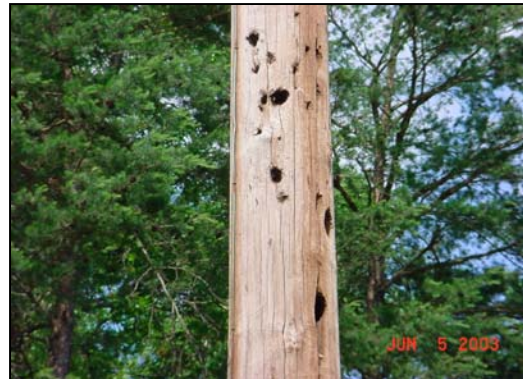
PHOTO 33: Wood Pecker Holes Limit the Strength and Shorten the Life of Wood Poles

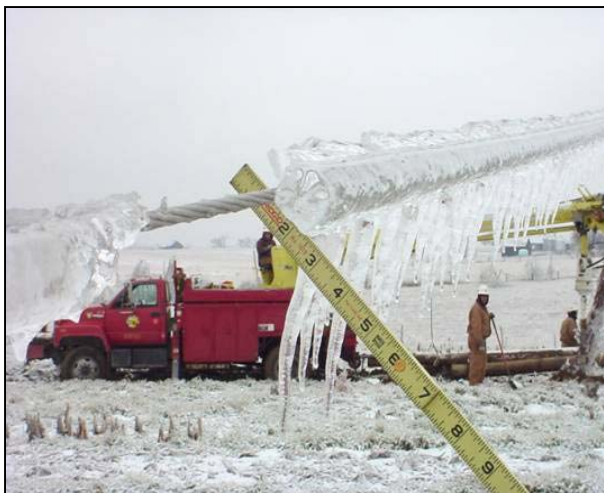
PHOTO 34: Ice Accumulation on #2ACSR Wire Near Lexington, KY
