FINAL REPORT

February 6, 2004

Assessment of the February 2003 Ice Storm

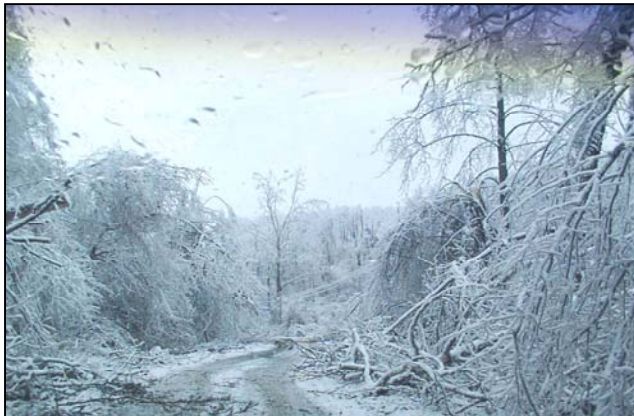
PHOTO 2: Typical Road Access Into Most Rural Areas Hit By The February Storm

The February 2003 ice storm that struck Central Kentucky demonstrated both the vulnerability of overhead transmission and distribution systems and the major impact they play in our everyday lives. See **PHOTO 2**.

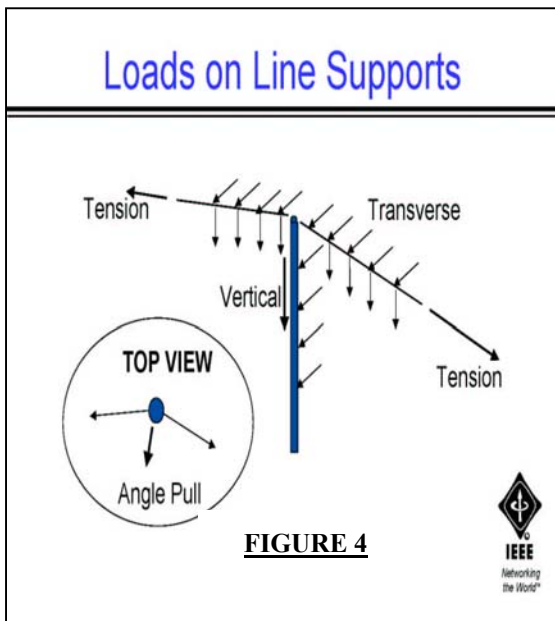
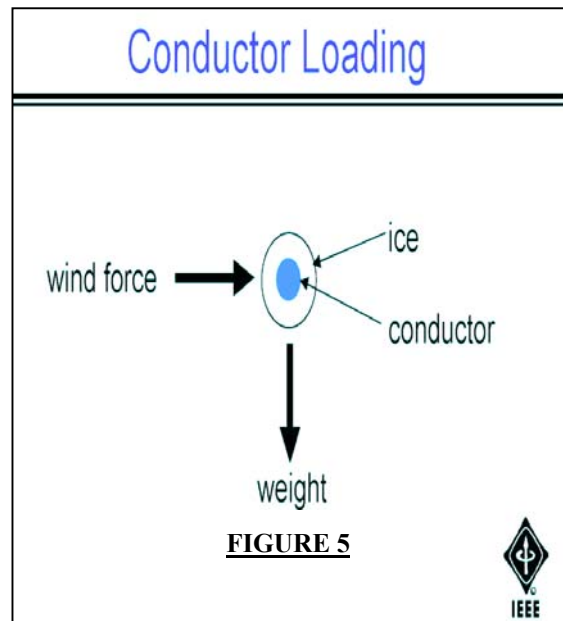
These dramatic load increases are transferred through to the poles, guy wires and anchors causing them to possibly fail. See FIGURES 4 and 5.

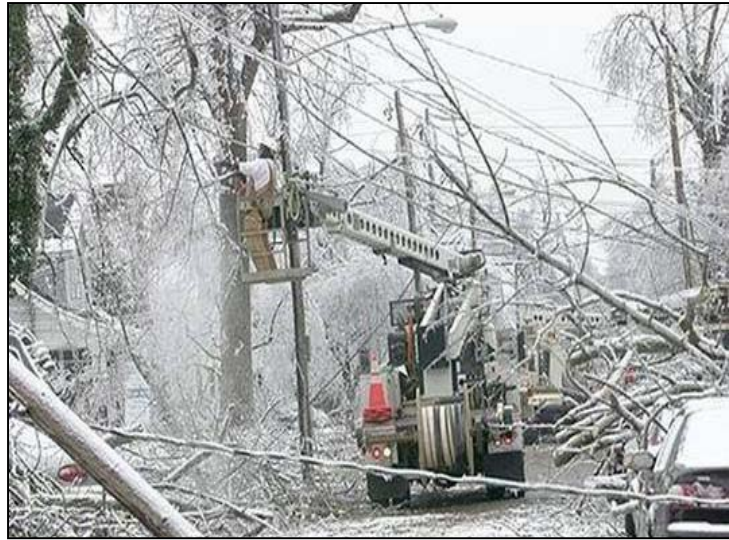
PHOTO 9: Alltel Repair Crew ~ Lexington, KY

This section outlines the general procedures used for damage assessment by each of the utilities affected and describes the problems presented by the ice storm damage. The principal focus is on the electric utilities and their efforts, although similar processes are in place for telephone utilities. See

PHOTO 9. However, in most cases, safety considerations require that telephone utilities wait for electric facility repairs to be completed before starting their restoration work. For

example, Alltel stated, “*Safety was a prime consideration when prioritizing repairs. Great care was taken to ensure that Alltel employees were not placed in harm’s way or that Alltel crews did not interfere with the restoration efforts of the power companies. Downed power lines had to be cleared before Alltel personnel were allowed to enter an area to begin restoring telephone service.*” See **APPENDIX N1**.

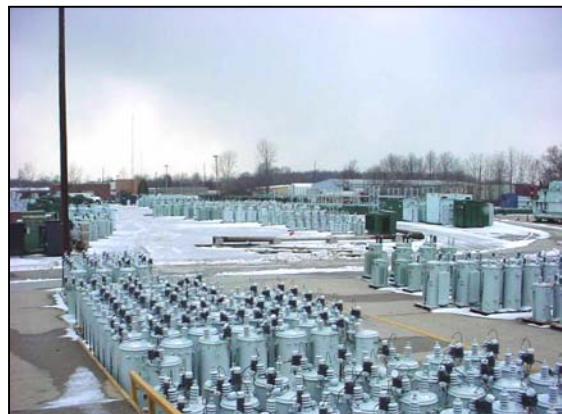
PHOTO 10: KU / LGE Transformer Storage Facility

Material handling for KU presented a challenge because of the massive amounts of materials needed for repairs, as well as supplies to support over 2,000 employees engaged in the restoration. **See PHOTO 10.**

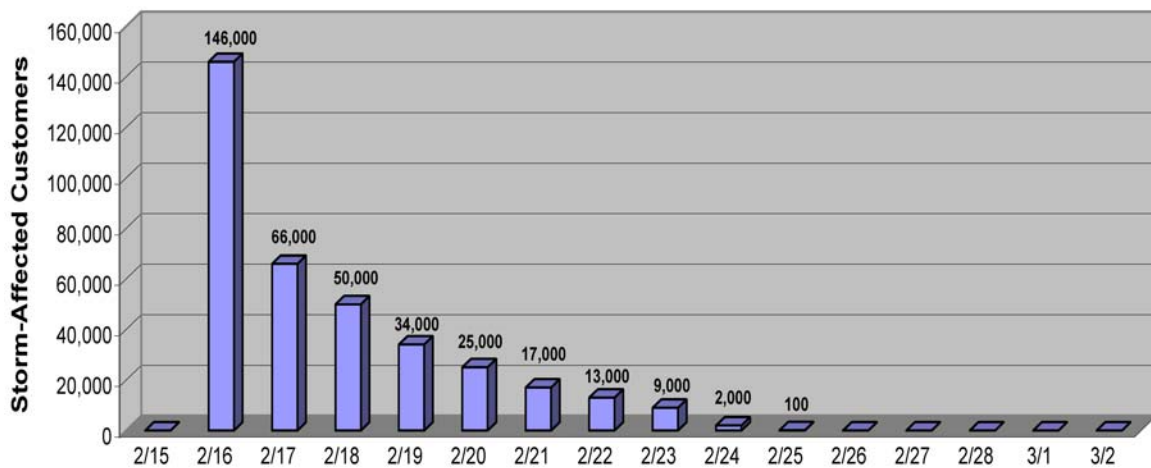
GRAPH 5: Timeline of KU Outage Restoration

The freezing rain that began falling during the evening of February 15 resulted in 146,000 KU customers without power on Sunday, February 16. The efforts of 483 KU employees and 544 contract employees reduced the number of customers without power to 66,000 by Monday, February 17. Contract crews were added until Thursday, February 20, bringing the total number of workers to 2,334. As the number of mutual aid crews increased, KU employees were shifted to “bird dog” or guide those crews around the system. This level of staffing was maintained until Sunday, February 25, when substantially all customers were back in service. **GRAPH 5** shows the number of customers without service on each day.

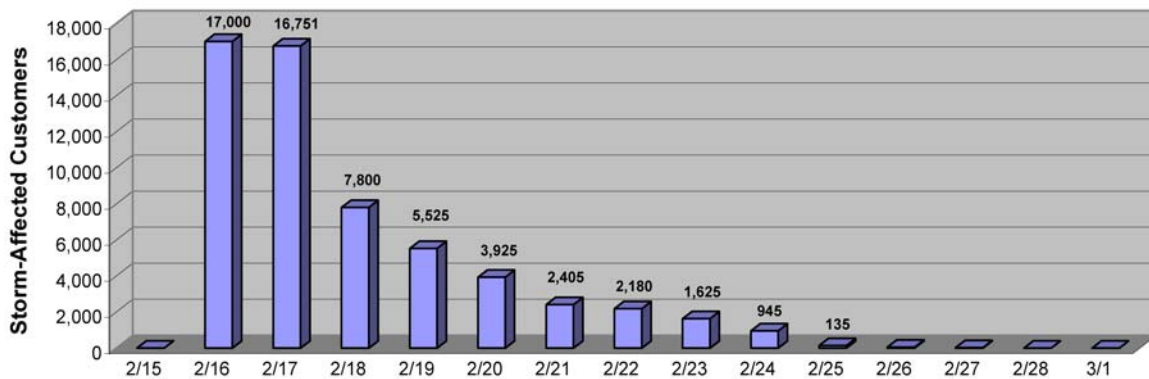
GRAPH 8: Timeline of KPC Outage Restoration

Kentucky Power Company’s restoration efforts were slowed by the duration of the storm and falling ice and rebounding trees as the ice melted. **Graph 8** shows the net number of customers restored to service, as customers were restored others lost service.

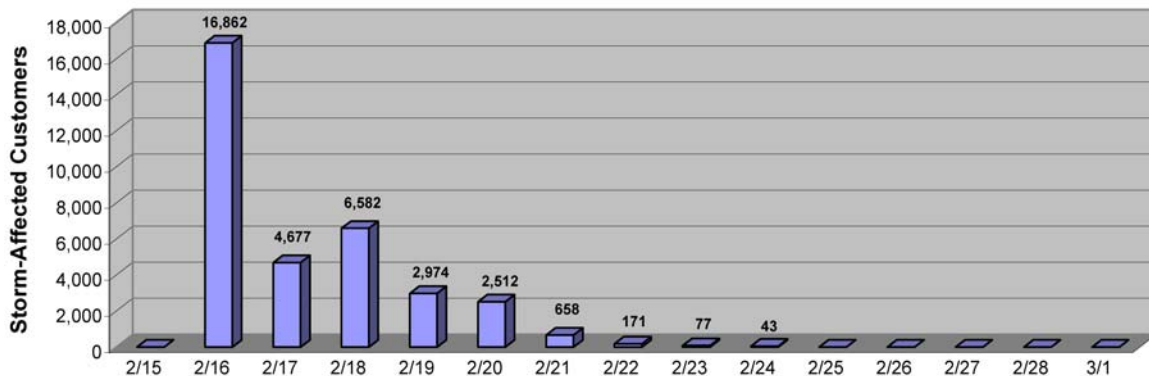
GRAPH 11: Timeline of Clark Energy Outage Restoration

Clark’s restoration efforts were slowed by the duration of the storm and falling ice and rebounding trees as the ice melted. Approximately 70 percent of Clark’s customers lost power during the event. **GRAPH 11** shows the net number of customers restored to service, as customers were restored others lost service.

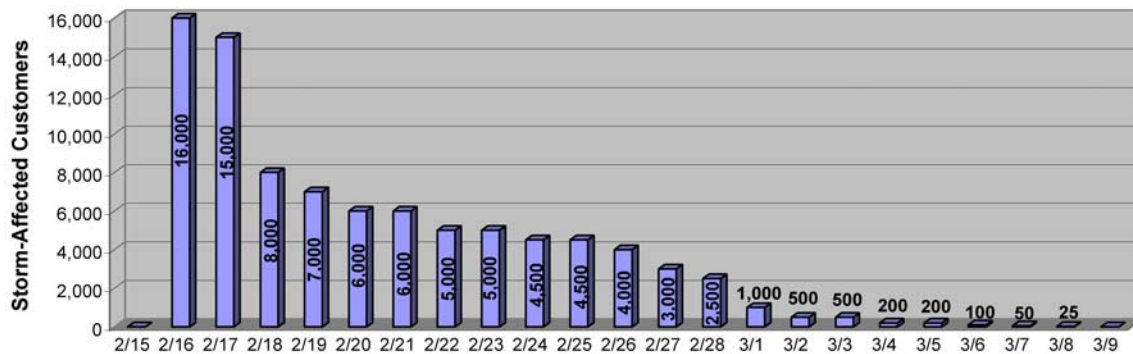
GRAPH 13: Timeline of Grayson RECC Energy Outage Restoration

Grayson’s restoration efforts were slowed by the condition of the roads, the duration of the storm, and falling ice and rebounding trees as the ice melted. Grayson also did not have access to all of the contract labor that it could have used. Grayson reported that it has had no reason in recent years to form relationships with contractors outside of the few that routinely do work for them. Other contractors were obligated to serve the utilities with which they have current contractual relationships. **GRAPH 13** shows the net customers restored to service, as customers were restored others lost service.

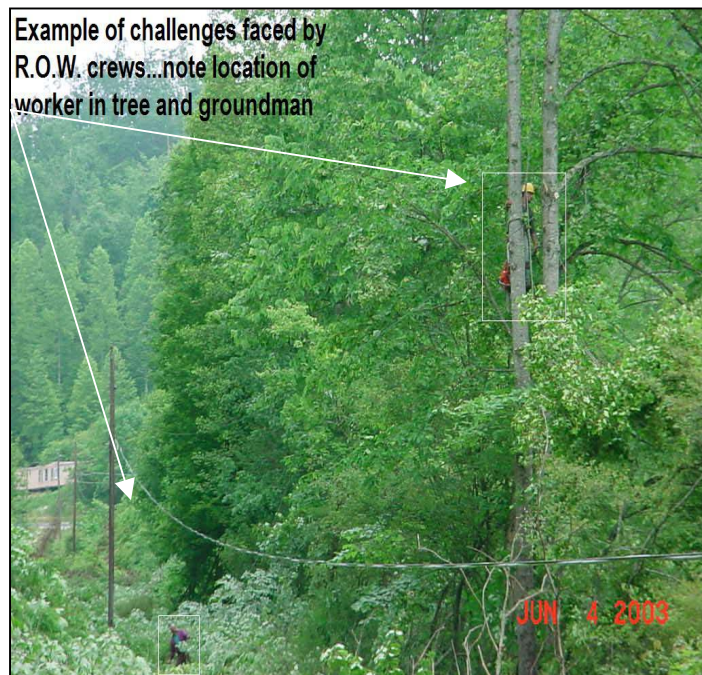
PHOTO 12: Typical Line Clearance Work

Even on the best of days, line clearance is not an easy task. Climbing crews have to work in trees near electric lines and with chain saws while sometimes working 50 feet or more in the air. **See PHOTO 12.** Icy and cold conditions significantly hinder such work and increase its danger significantly.

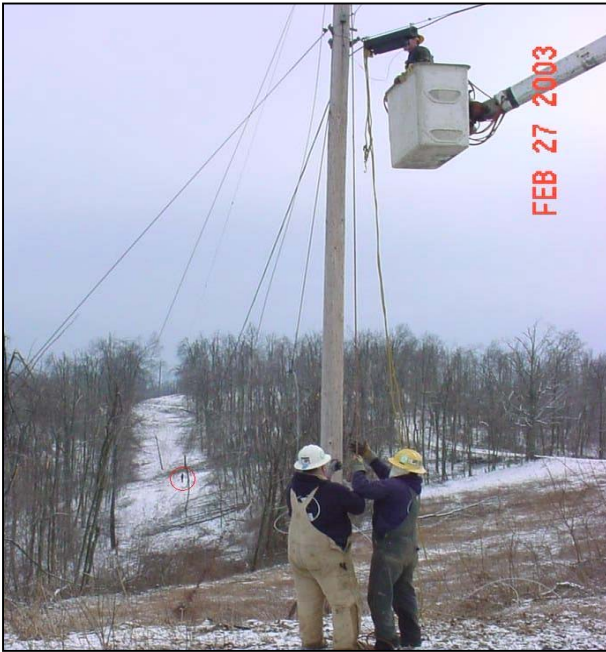
PHOTO 13: Lewis County, KY ~ Pike Contractor and Grayson Crew... Note Lineman in Distant R/W

Rural areas of Lewis, Carter, Fleming, and Greenup counties were some of the last to be restored (**APPENDIX N6 / O6; Fleming-Mason Energy and APPENDIX N7 / O7; Grayson RECC**) due to the remote nature of some of the lines in those areas. **PHOTO 13** shows a repair crew in rural Lewis County following the ice storm. Hours of work in such areas may result in only a few homes being restored. This is typical of many Rural Electric Co-op (“RECC”) and rural areas of Investor Owned Utilities (KU, AEP, etc.) in the state.

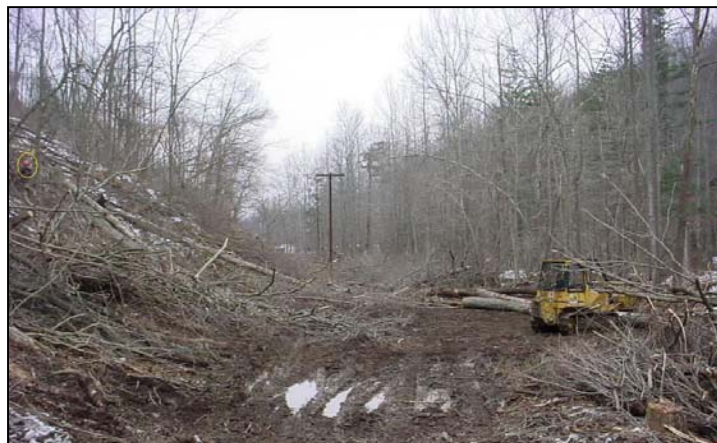
PHOTO 14: Lewis County, KY ~ Bulldozer Clearing R/W

To combat these challenges, crews used a variety of non-conventional methods to gain access to remote work areas. Bulldozers were used to clear R/W’s and pull trucks in and out of fields. Bulldozers also aided some areas in clearing or even establishing new R/W’s. **PHOTO 14** shows an example of this from Lewis County during the days of restoration work following the storm. Other vehicles like 4-wheelers

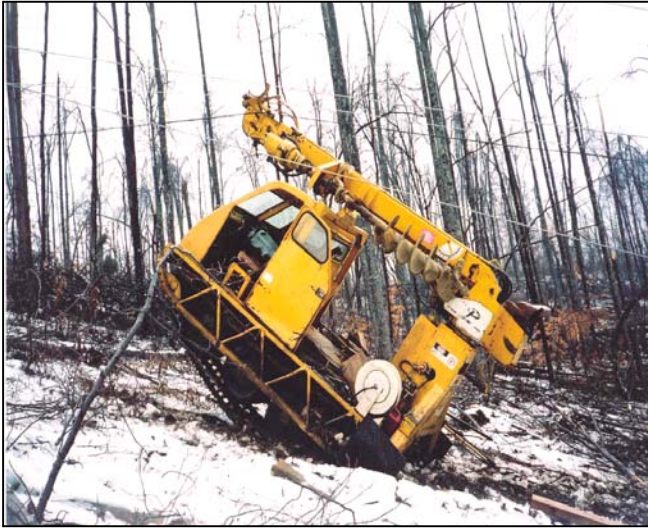
PHOTO 15: “All-Terrain” Tracked Digger-Derrick

and all-terrain tracked digger-derrick units provided some assistance to crews in spite of the harsh conditions. See **PHOTO 15**. However, most companies and contractors do not commonly maintain large numbers of these or similar units. Carrying tools, clearing the downed limbs and trees, and untangling wires and branches by manual labor remained the standard means of restoration. Even without the ice, the ground was saturated with moisture limiting normal accessibility for trucks and equipment.

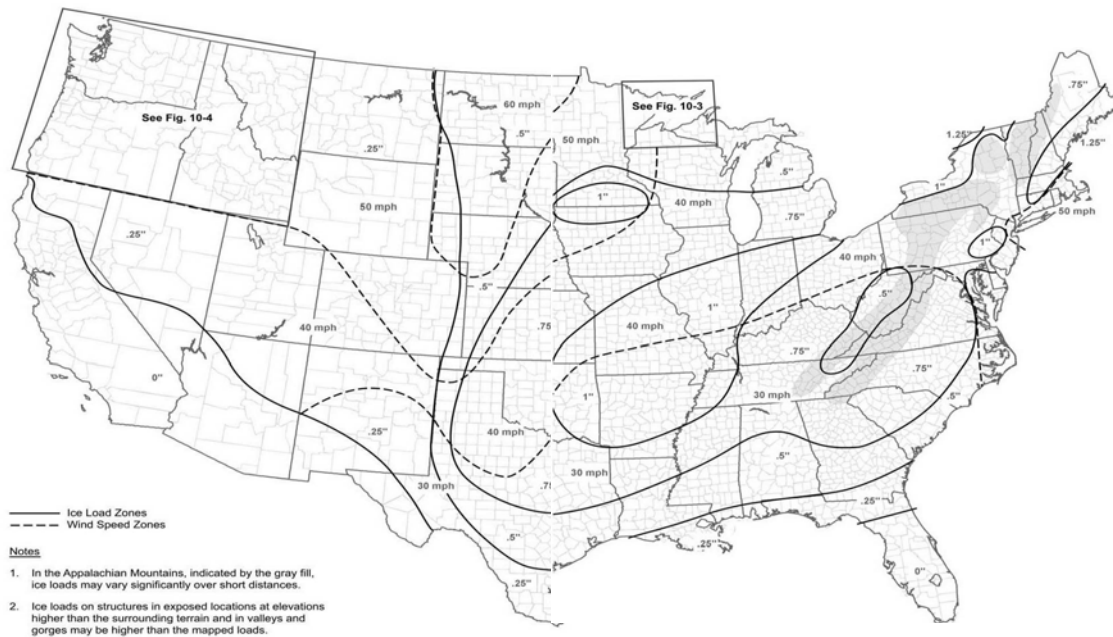
FIGURE 8: Proposed NESC Ice and Wind Combination Loading Map

What can a utility do to better handle the next ice storm? Unfortunately, the existing weather data system does not include historically accurate information concerning ice accumulation. **FIGURE 8** reflects the most up-to-date data on radial ice accumulation in the United States. This map was prepared for use in the manual - *Minimum Design Loads for Buildings and Other Structures*, and modified for use on overhead utility lines. It depicts the ice and wind loads that can be expected with a 1 in 50 chance of occurrence in any one year.

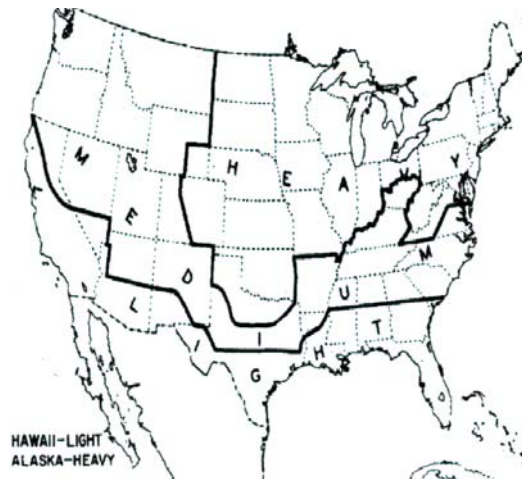
FIGURE 9: NESC Ice and Wind Loads

Utilities in Kentucky currently design their distribution systems for ice in accordance with the National Electrical Safety Code (NESC) medium loading district. (See **APPENDIX A, FIGURE 9 and TABLE 4, page 31**) The maximum amount of ice that can accumulate on a wire has been disputed by field observations during past ice storms. Some suggest that ice accumulation can increase indefinitely, depending on the storm's duration. At some point the weight of the ice will exceed the strength of the ice, with the result that the ice will break away. Most small-diameter conductor will break when the radial ice thickness exceeds one inch.

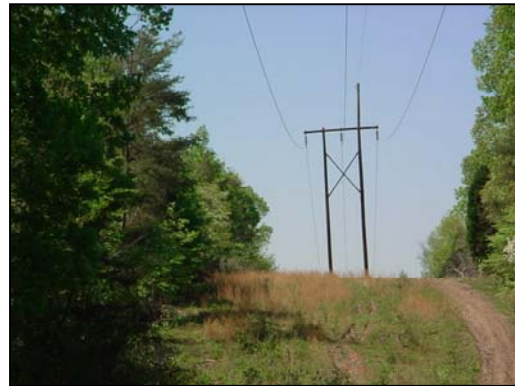
**PHOTO 21: Typical 69kV
Transmission Line in Rural KY**

Although there were some interruptions during the ice storm caused by damaged transmission lines, the vast majority of outages were due to failures on distribution systems. Transmission circuits avoided the catastrophic results that befell other lines for a number of reasons. Taller structures allowed cables to clear most of the trees that fell. Heavier construction designs allowed more stress to be absorbed by the lines, poles and towers without failure on transmission structures. But, most significantly, R/W for these lines is much wider, better established and more strictly maintained. See **PHOTO 21**.

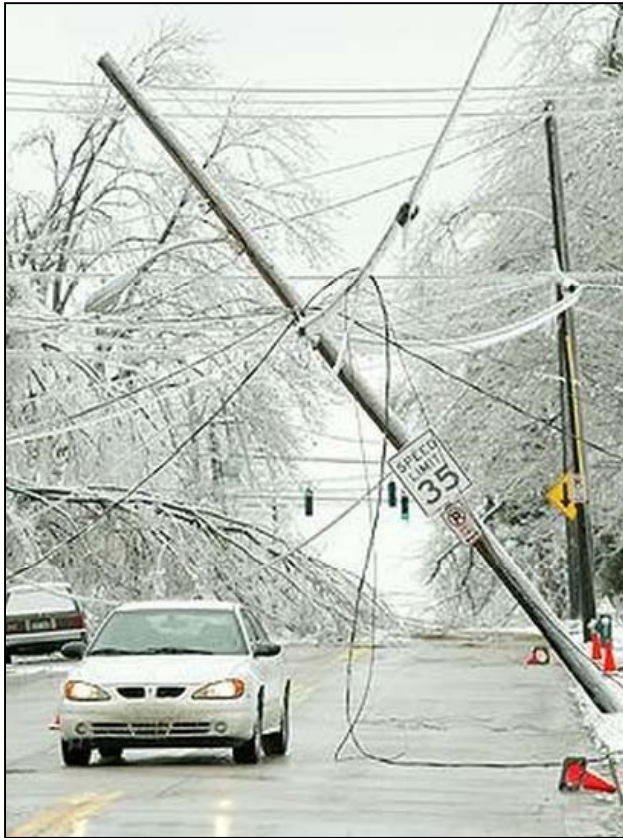
PHOTO 22: Lexington, KY Street

Damage to the state's electric distribution system from the 2003 ice storm was tremendous. An estimated 255,000 electric customers lost power at some point during the week of February 16–22. Some of the damage included over 3,100 poles that were broken within the affected areas. Most of these were damaged by either the weight of the ice on the lines or by the ice causing trees and limbs to fall onto the poles and wires. **See PHOTO 22.**

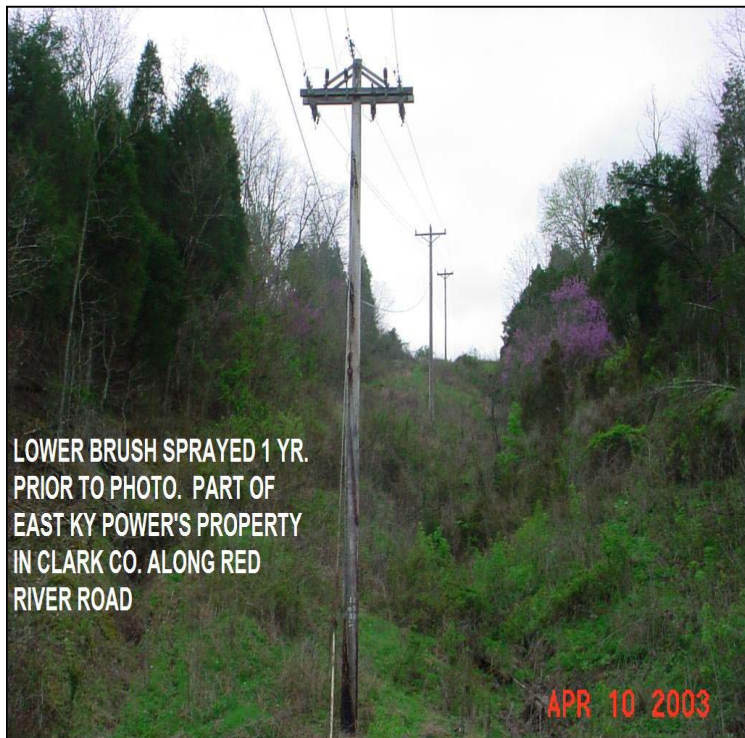
PHOTO 25: Benefits of Herbicide Treatment

Most VM programs include herbicide spray applications to areas following a trimming. This allows the vegetation's growth to be limited, thus lessening the need for future trimming. An additional benefit of spraying is a more accessible R/W for maintenance and repair purposes. **PHOTO 25** shows R/W that was recently trimmed and sprayed. Underbrush and smaller vegetation is minimized with properly applied sprays and chemical treatments. Spray treatments are somewhat limited in their use due to environmental concerns and precautions. Rural areas away from streams and creeks are the most likely places to have the full benefit of herbicide treatments.

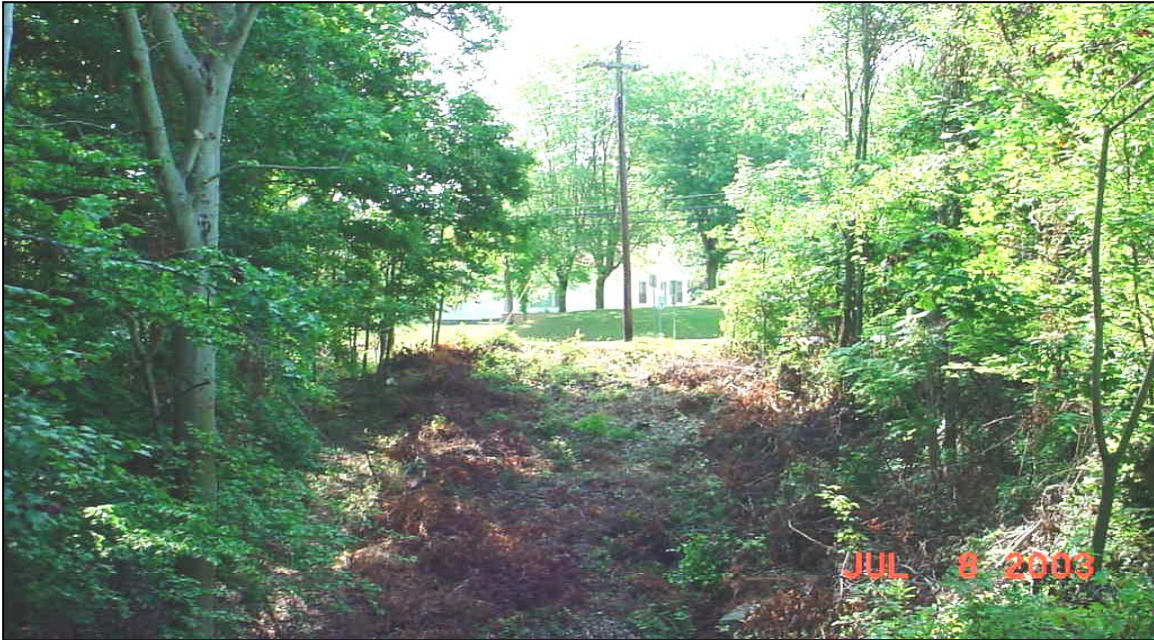
PHOTO 26: Bush-Hogged R/W

shows a R/W where there has been some effort made to remove the cut limbs and brush. Bush-hogging the ground under a R/W is also a common practice to maintain accessibility where applicable. While some of these practices take extra time and effort initially, those areas that have incorporated such plans into their VM programs reap the benefits of later cost savings and fewer outage hours.

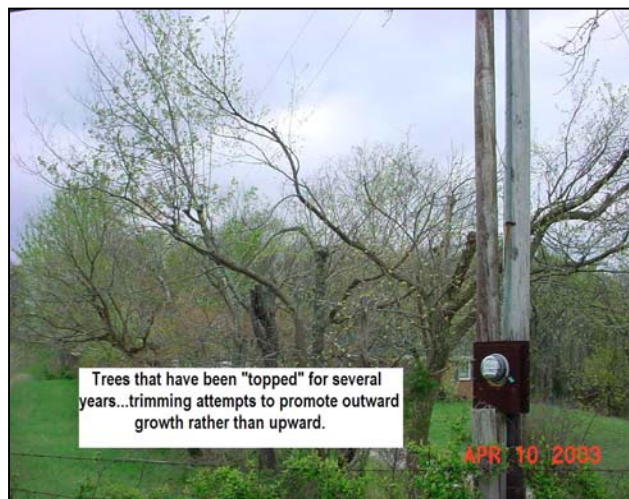
PHOTO 29: Typical "V-Notched" Tree Trimming

PHOTO 29 shows trees that have been "topped" for several years. The property owner or utility has been unwilling to have the trees removed.

The resulting line clearance trimmings have left the trees in a “V-notch” condition. This trimming procedure may allow for minimal initial cost to trim but the present-worth of the ongoing cost can be much greater. Also, while this may maintain clearance to avoid tree contact with the energized conductors it does have the possibility of increased liability due to public contact with and/or increased restoration time for downed lines.

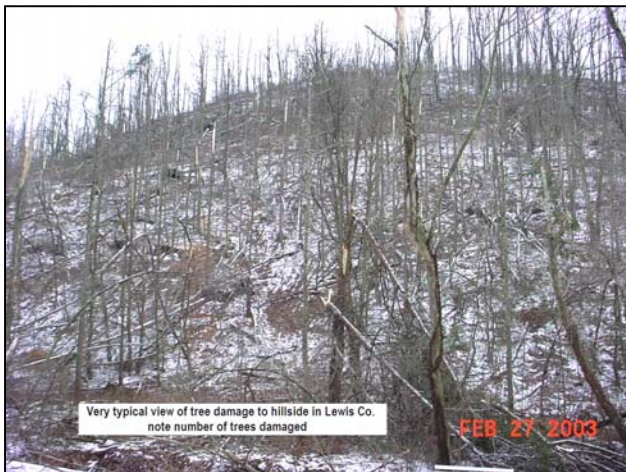
PHOTO 30: Lewis County, KY

Geographically, the Northeastern and Central counties of Kentucky saw the most build-up of ice during the days of February 15-16. A total of 51 counties were declared disaster areas as a result of the ice storm’s damage. Utility line damage was widespread but particularly bad in Lewis, Carter, Greenup, and Fayette counties. **PHOTOS 30 and 31** provide some example of tree damage in Lewis and Fayette counties.
